# Progetto CoupEvent: Hillslope - Channel coupling during extreme events in South Tyrol

## Monitoring storm-induced morphological effects in a dolomitic catchment of the Italian Alps: insights for the understanding of the hillslope-channel sediment coupling

Vittoria Scorpio<sup>a</sup>, Stefan Steger<sup>b</sup>, Marco Cavalli<sup>c</sup>, Francesco Comiti<sup>d</sup>

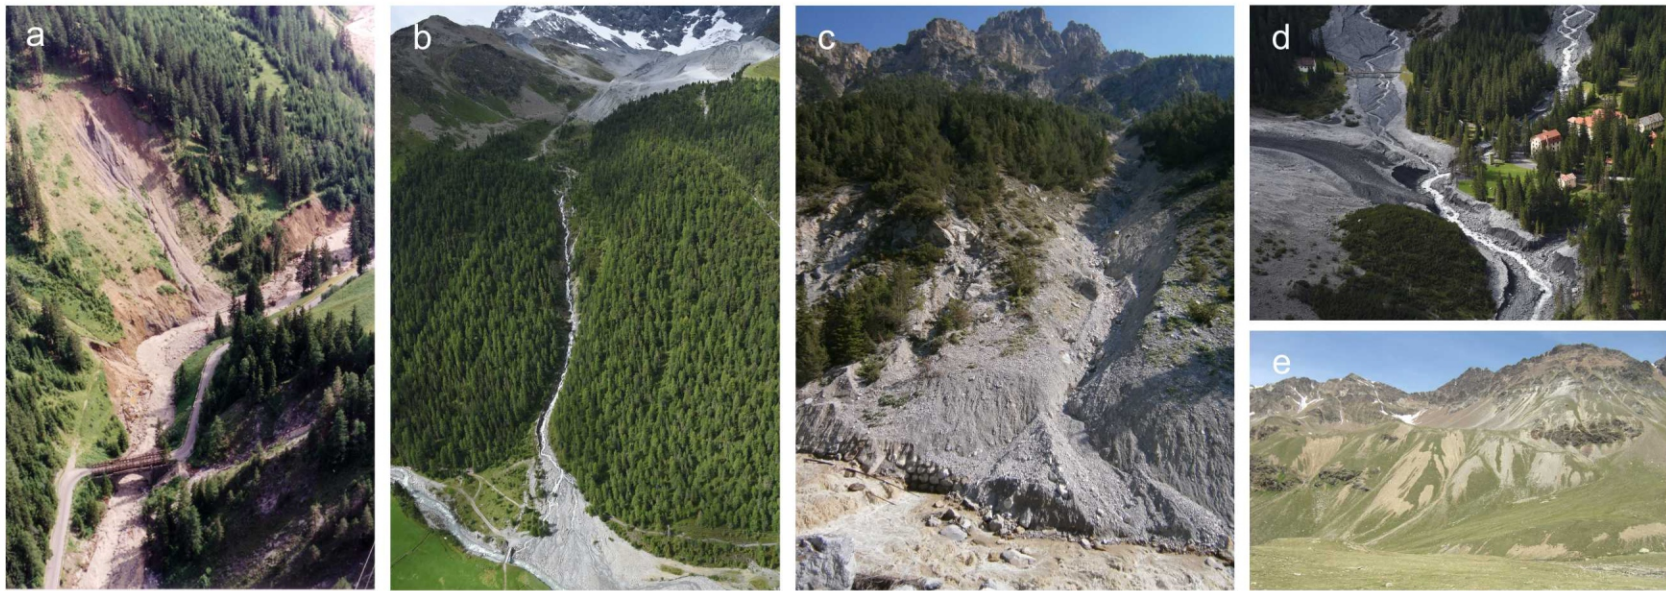
The coupling of hillslope processes with the channel network is of great relevance for the hydromorphological quality of mountain rivers but it may also bring about augmented flood hazards during extreme events(Fig. 1). To date, only few researches have focused on the interconnections among mass wasting processes, hillslope toe erosions and channel dynamics during extreme events. In order to fill this gap, the project "CoupEvent - Hillslope - Channel coupling during extreme events in South Tyrol" was proposed (Fig. 2).

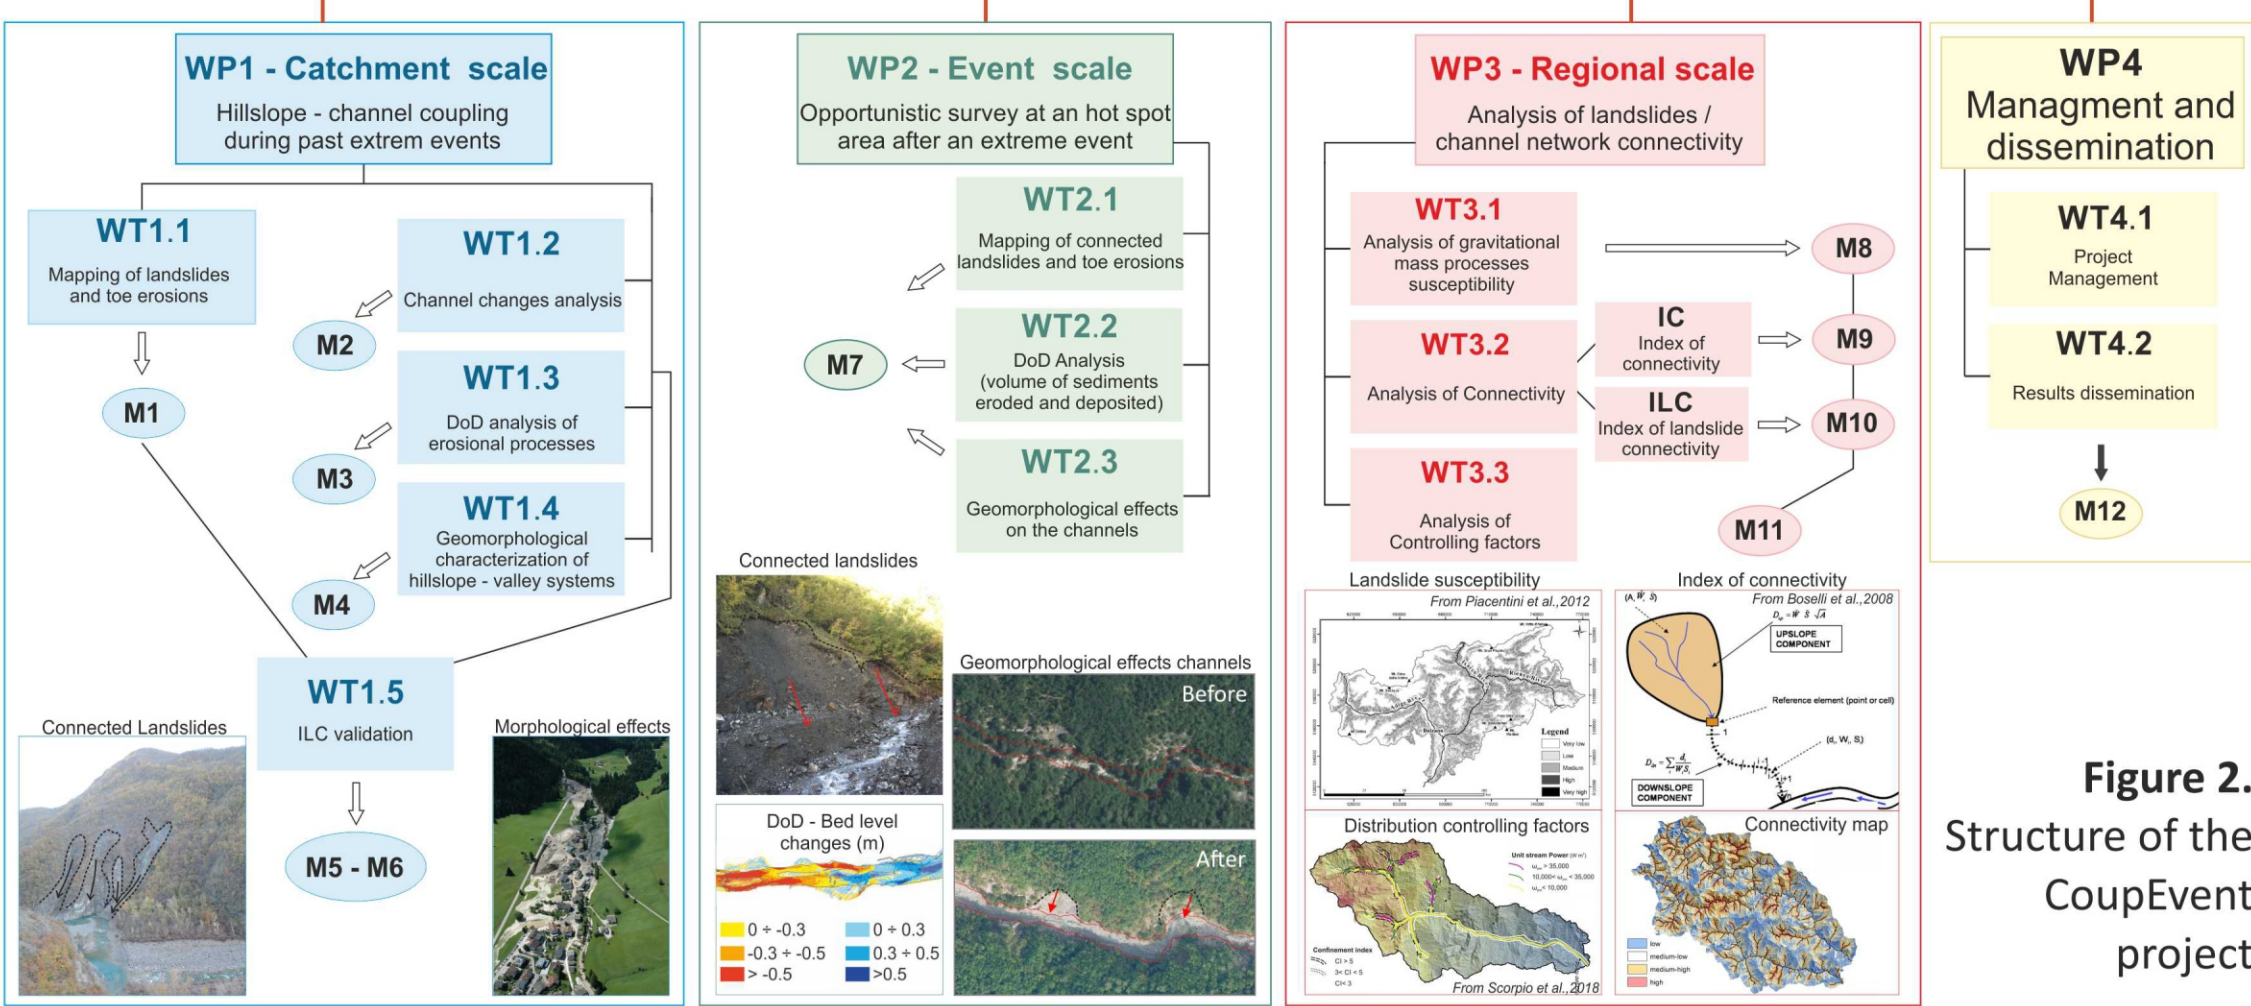
**Figure 2.** Structure of the CoupEvent project

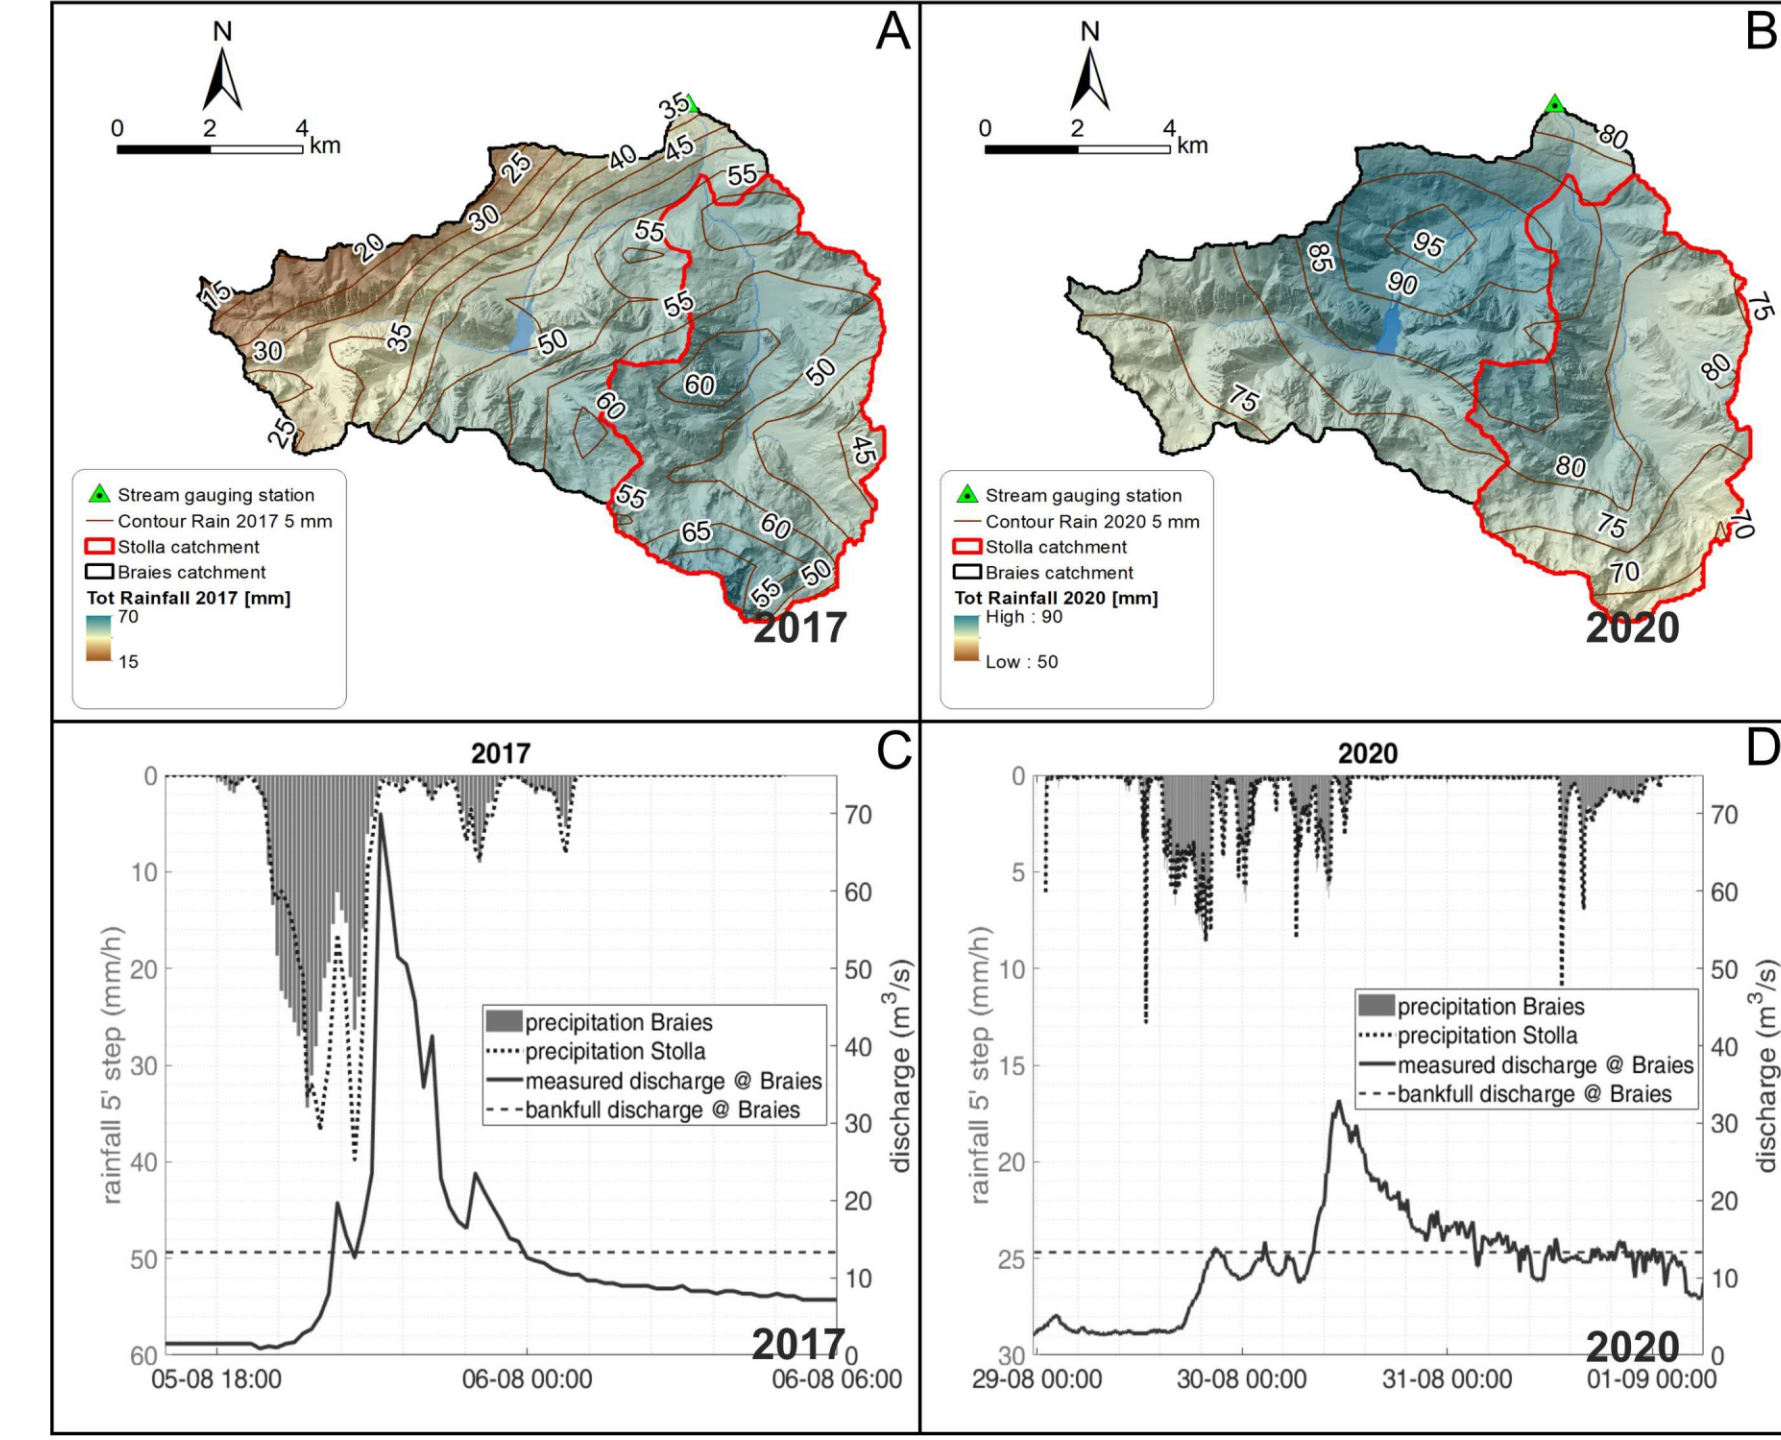
**Figure 5.** Cumulative rainfall for 2017 (A); and 2020 events (B); recorded flood hydrograph at the Braies station for 2017 (C); and 2020 events (D). Recorded hydrographs are reported in solid black line together with average catchment rainfall for the whole basin (grey bar) and for the Stolla sub-catchment (dotted line) for 2017 (C) and 2020 (D) events. Severe intensities for 2017 event emerge considering rainfall and discharge magnitude (C) while total rainfall and much longer duration for the 2020 event can be inferred at a glance comparing isohyets and patterns in panels A and B along with C and D plot timescale difference. As a reference, bakful discharge calculated for the Braies station is reported with a dashed line.

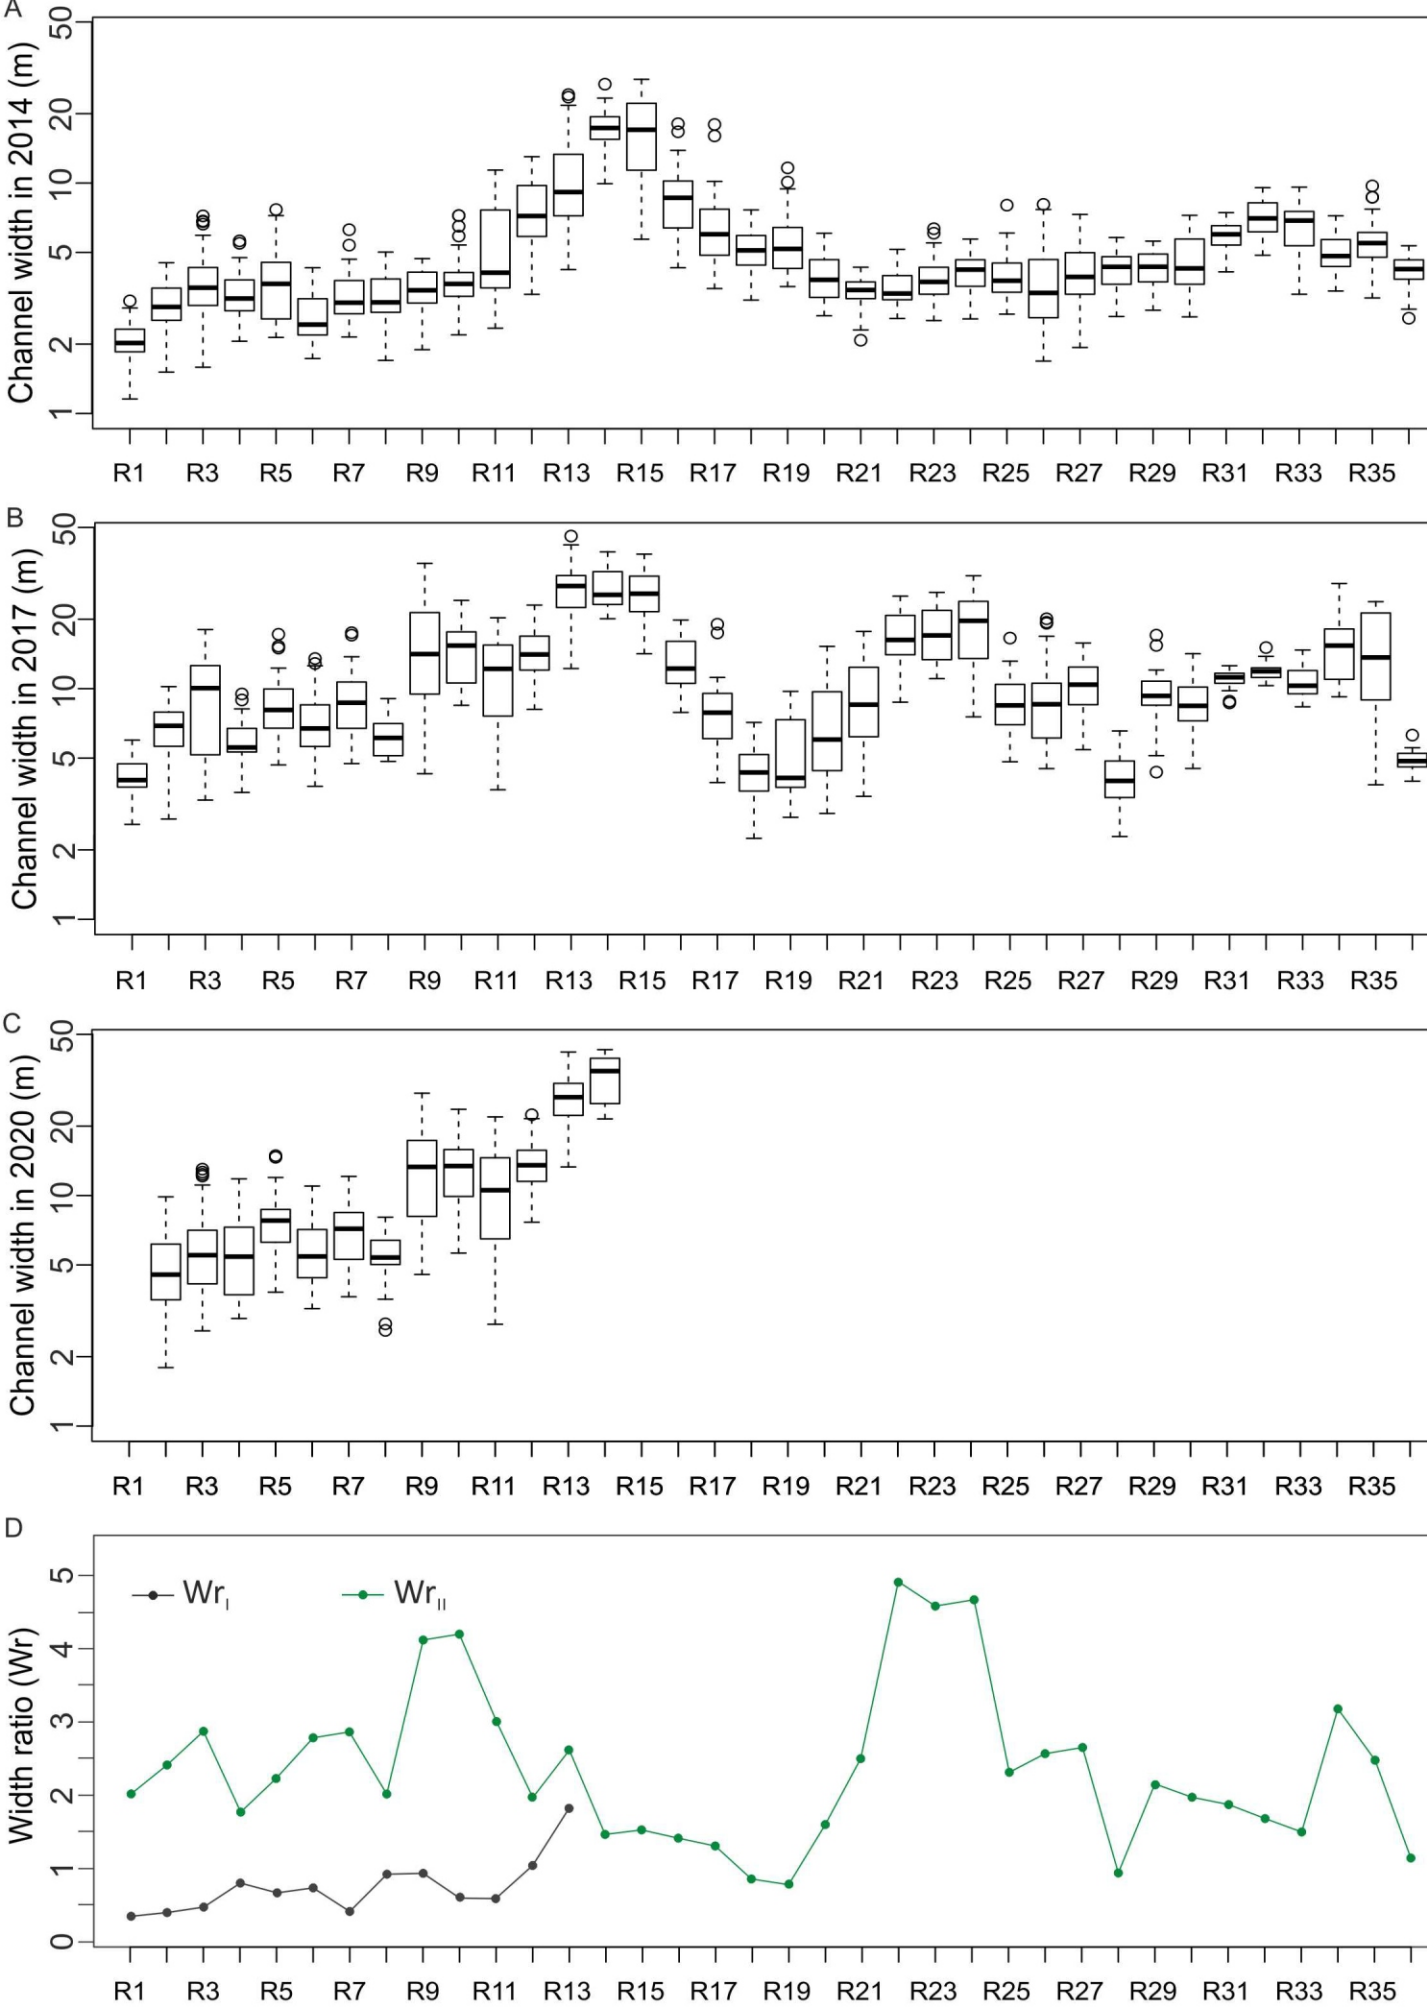
**Figure 6.** Channel width in 2014 (A), in 2017 (B), and in 2020 in the study reaches(C); median values of width ratio for the floods of 2017 (Wr) and 2020 (WrII) (D).

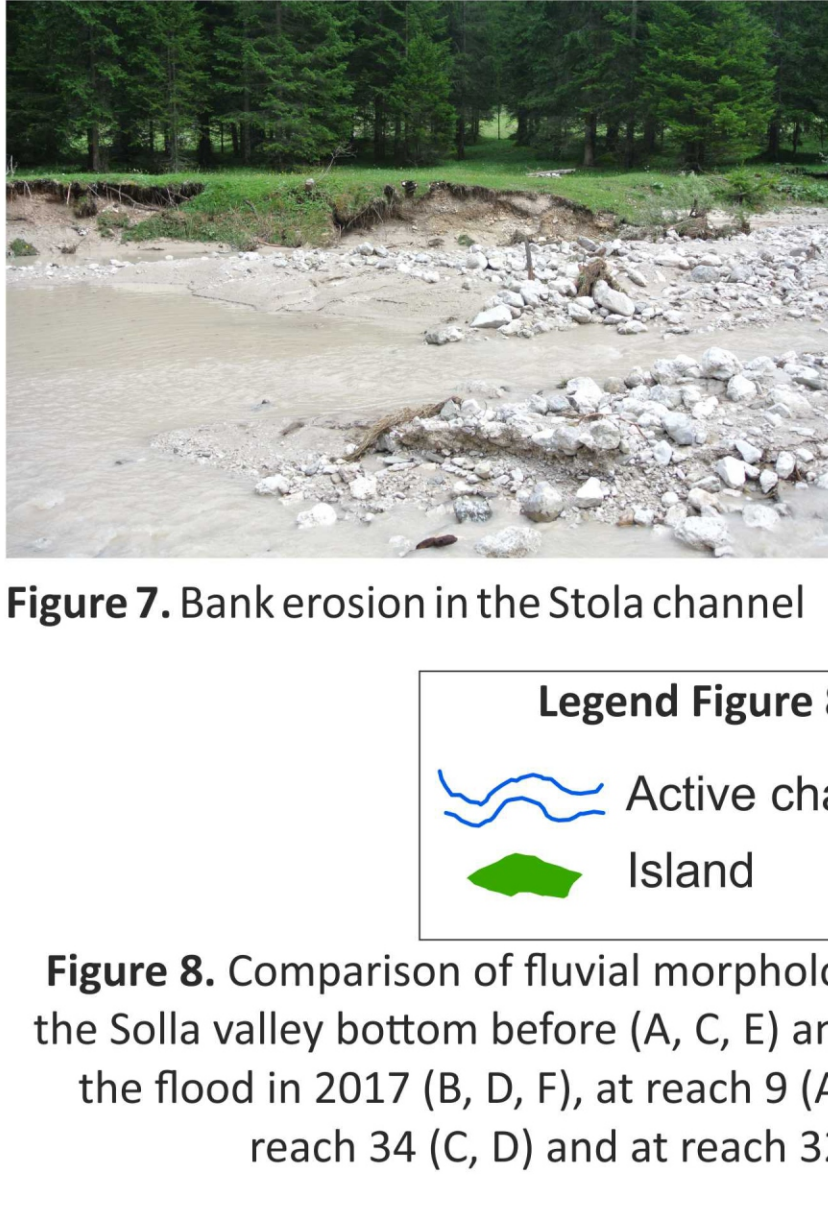
### Figure 7. Bank erosion in the Stolla channel

**Figure 7.** Bank erosion in the Stolla channel

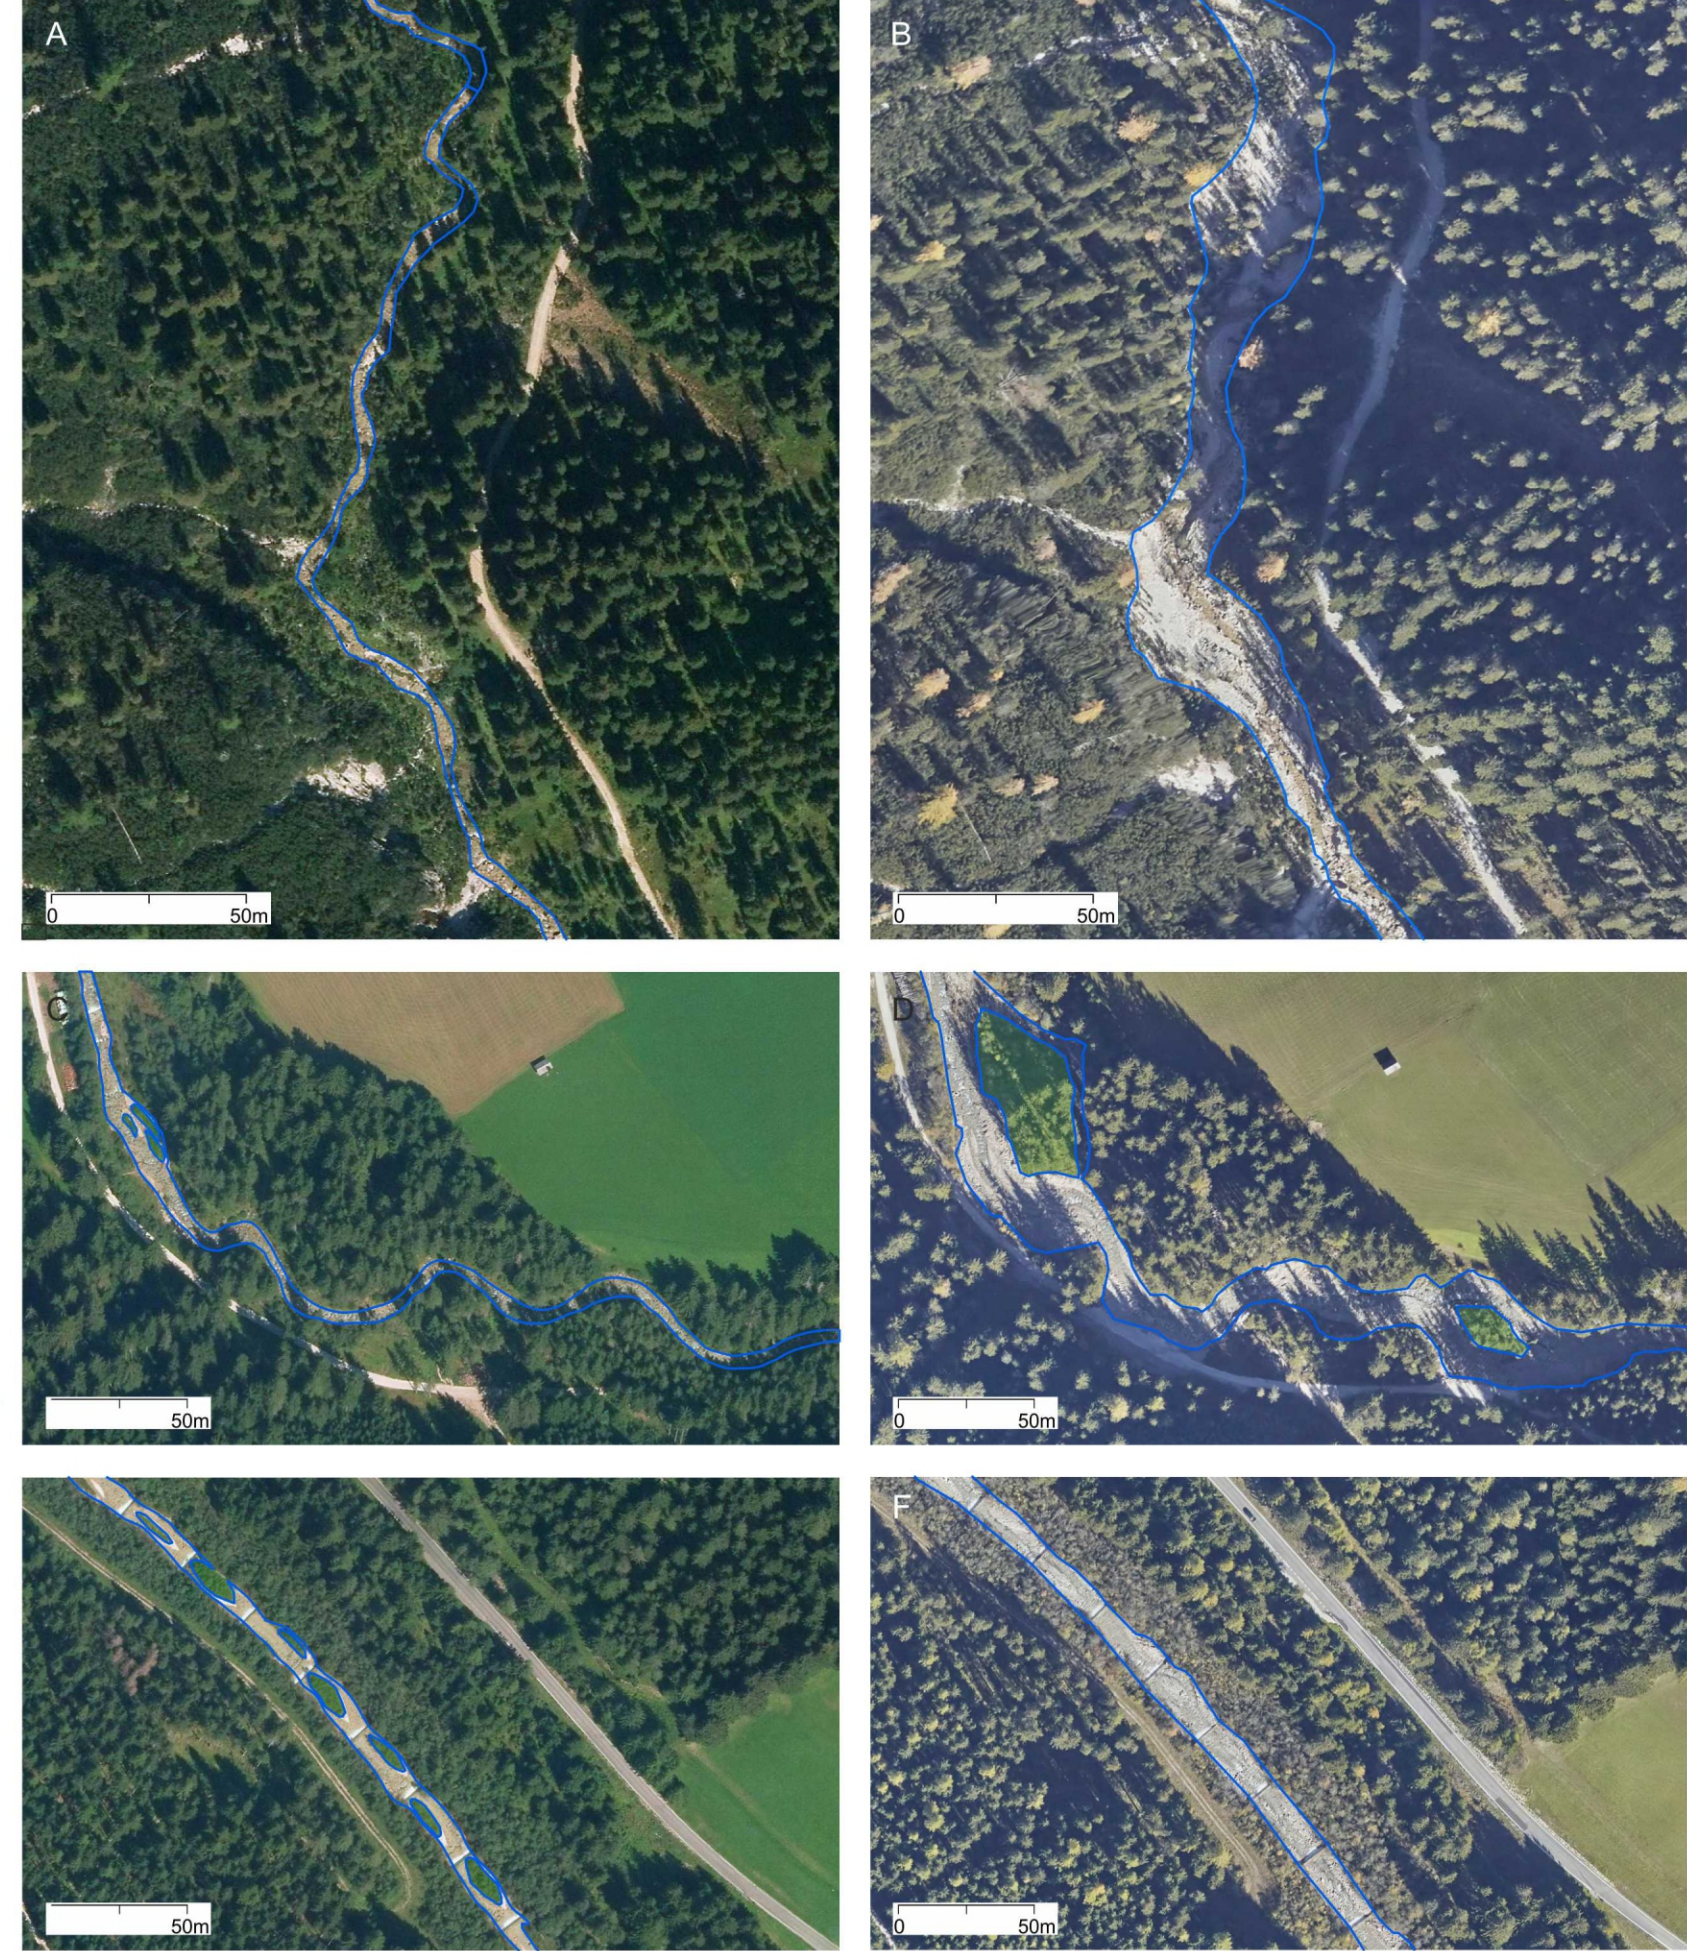
**Figure 8.** Comparison of fluvial morphologies in the Solla valley bottom before (A, C, E) and after the flood in 2017 (B, D, F), at reach 9 (A, B); at reach 34 (C, D) and at reach 32 (E, F).

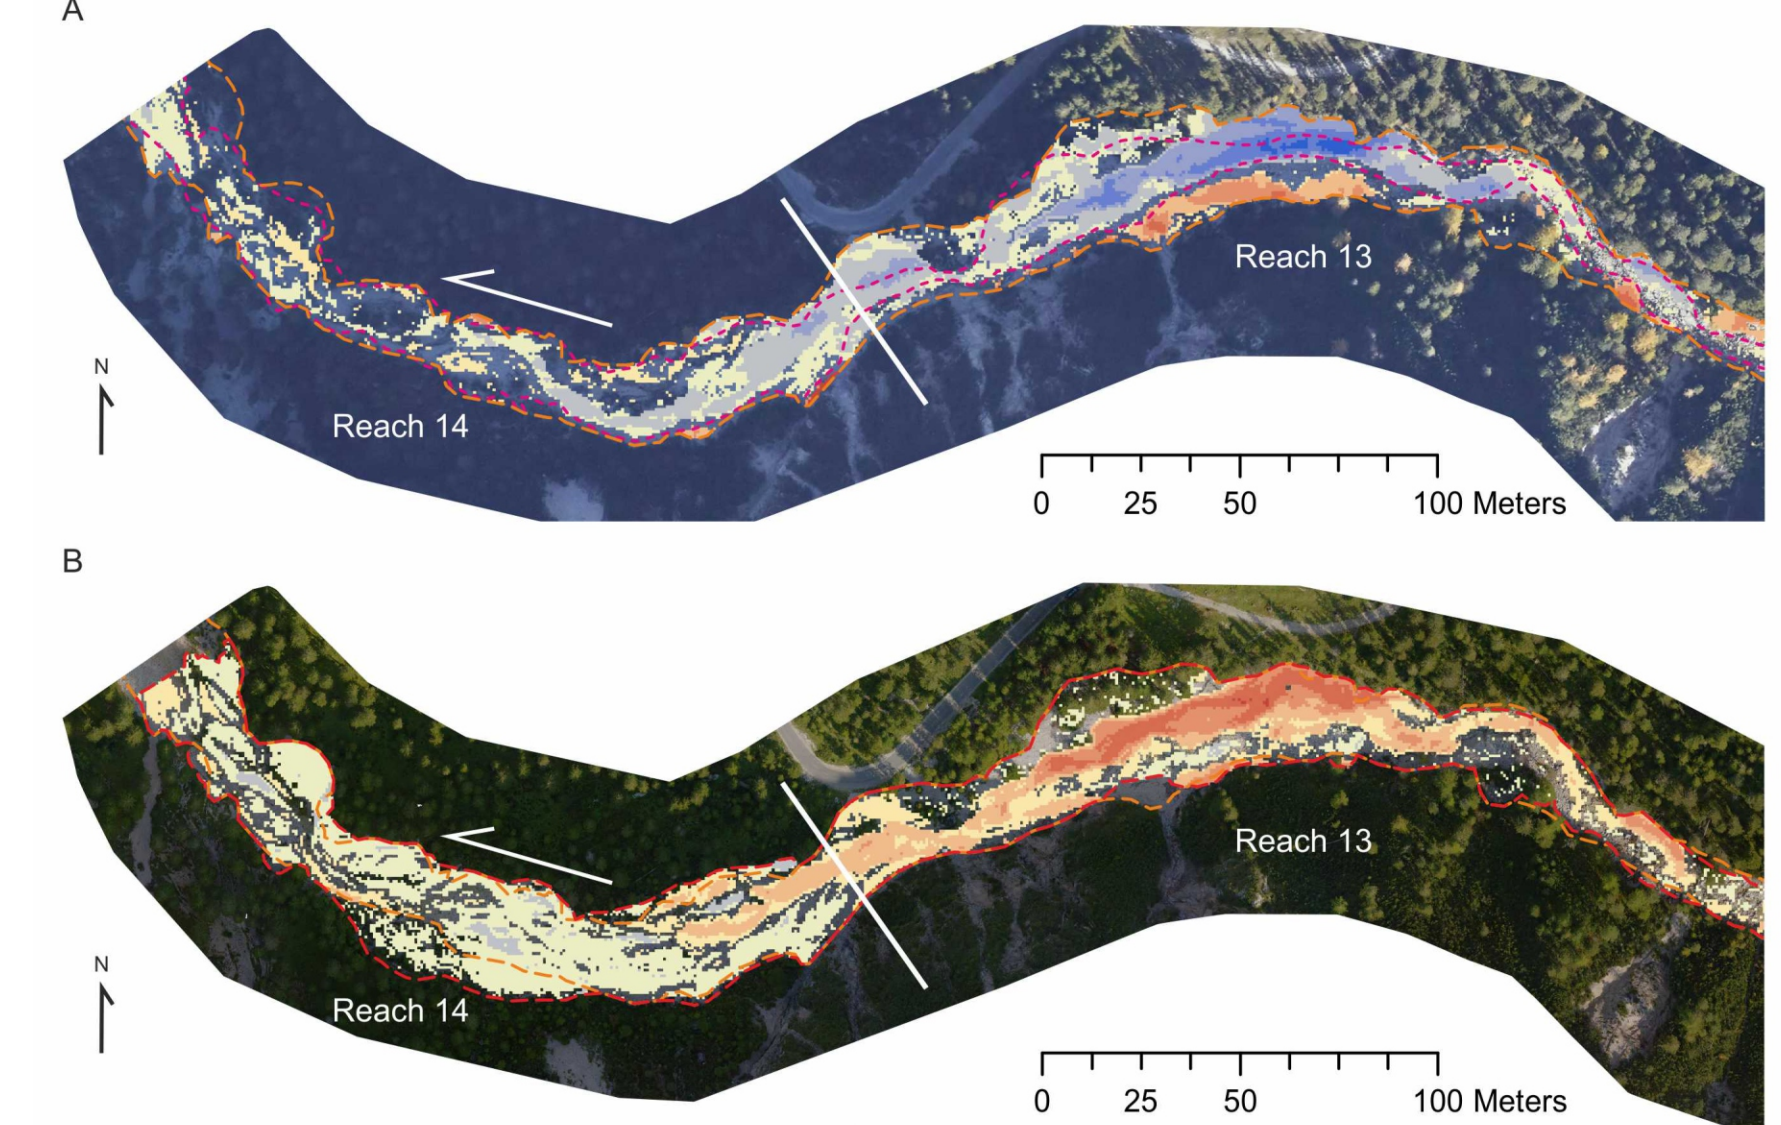
**Figure 9.** Bed level changes distribution at reaches 13 and 14 between 2010 and 2017 (A) and between 2017 and 2020 (B).

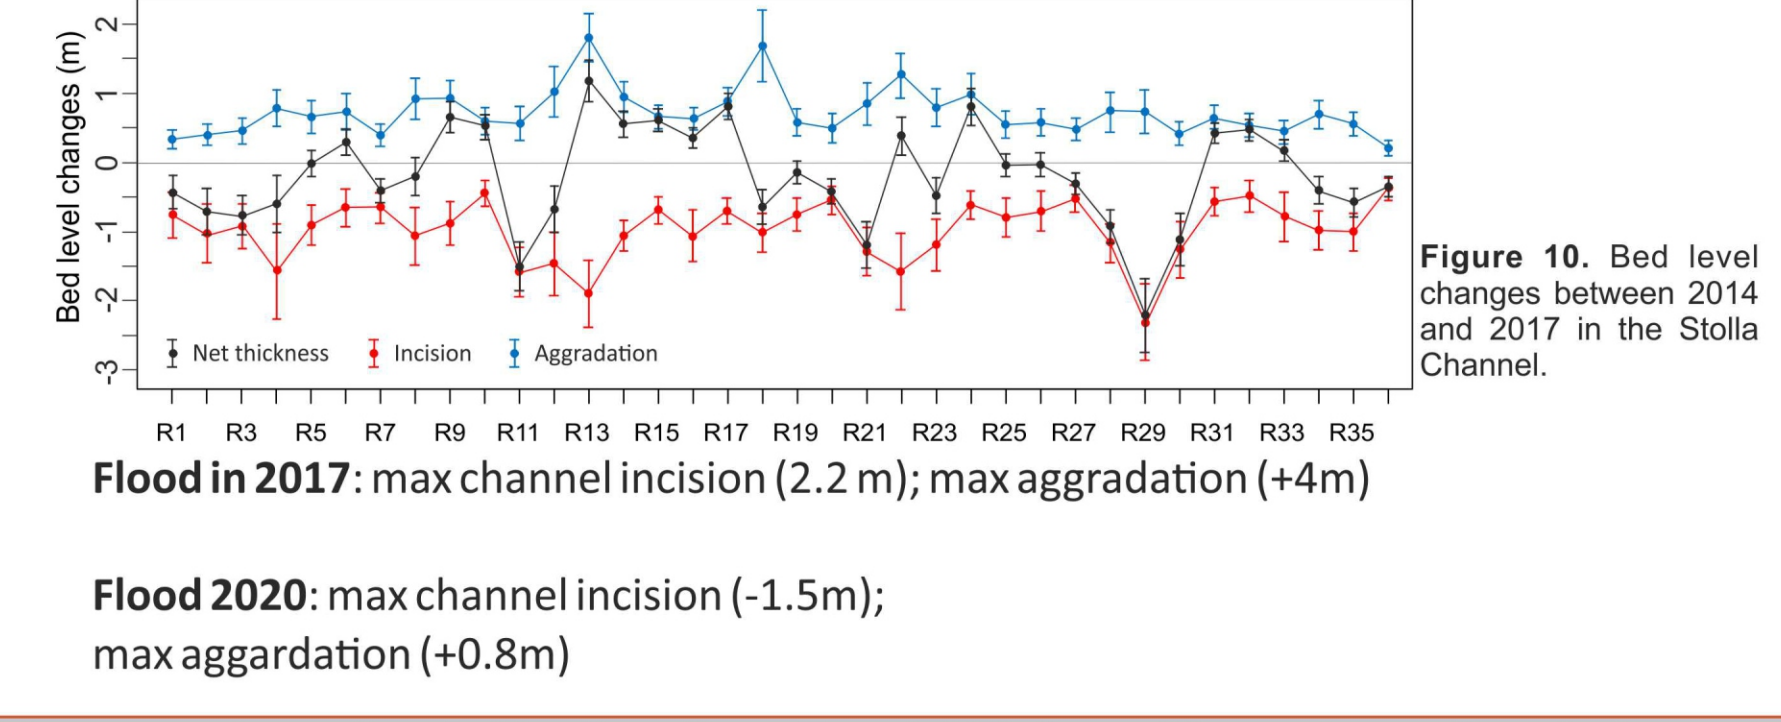
**Figure 10.** Bed level changes between 2014 and 2017 in the Stolla Channel.

### Flood in 2017: max channel incision (2.2 m); max aggradation (+4m)

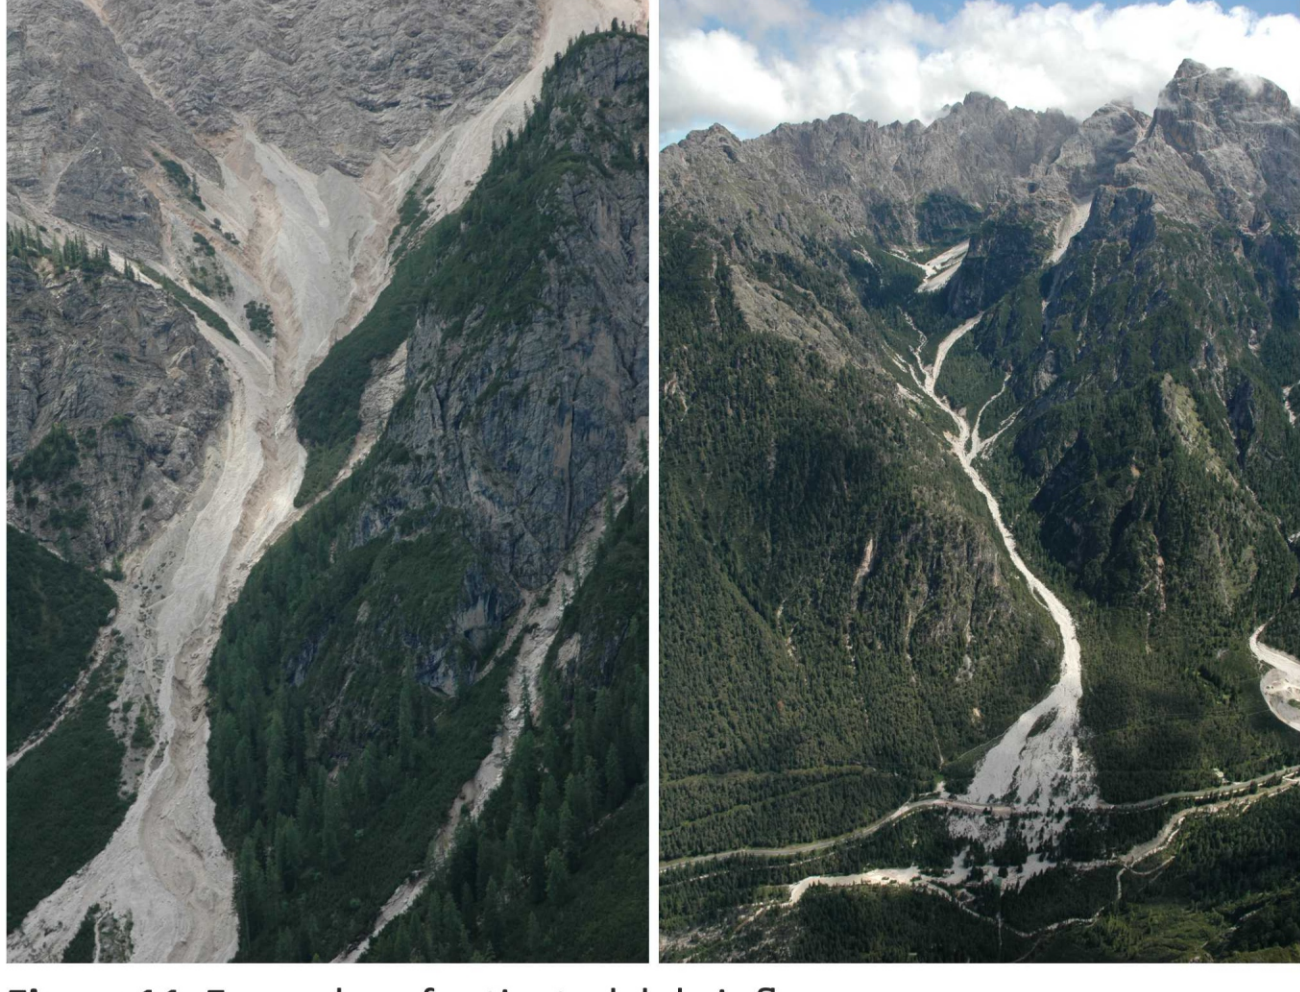
**Figure 11.** Examples of activated debris flows.

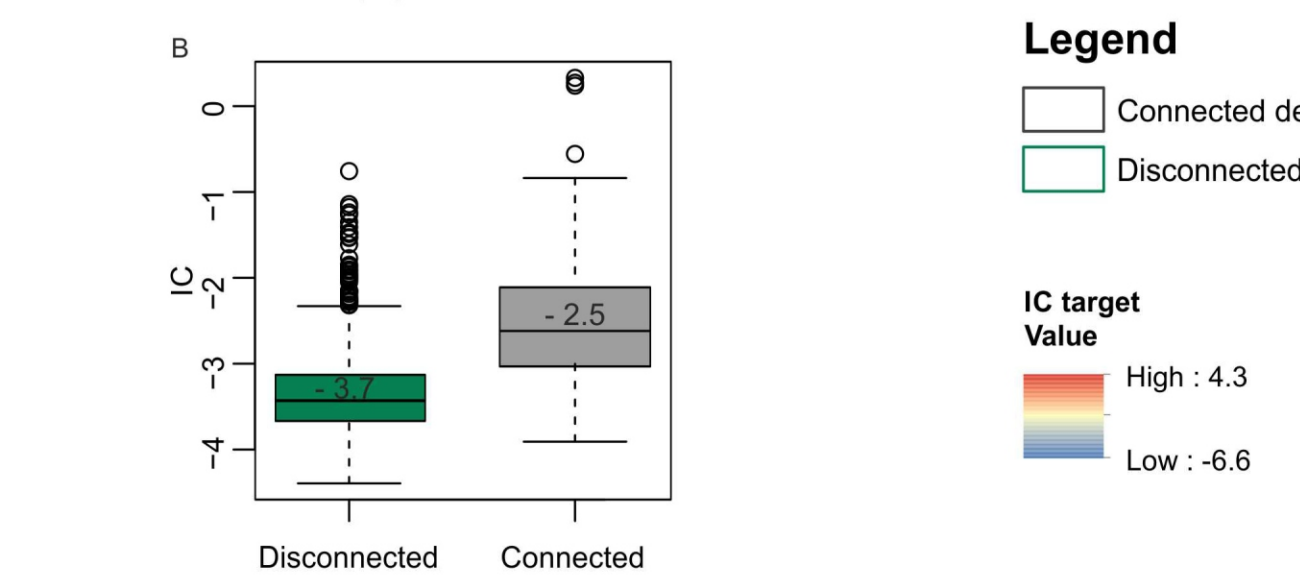
**Figure 12.** Map of index of Connectivity using the Stolla as target (A). Box and whiskers plots presenting median and interquartile range (25th and 75th percentiles), of the connected and disconnected debris flow with respect to the Stolla channel (B).

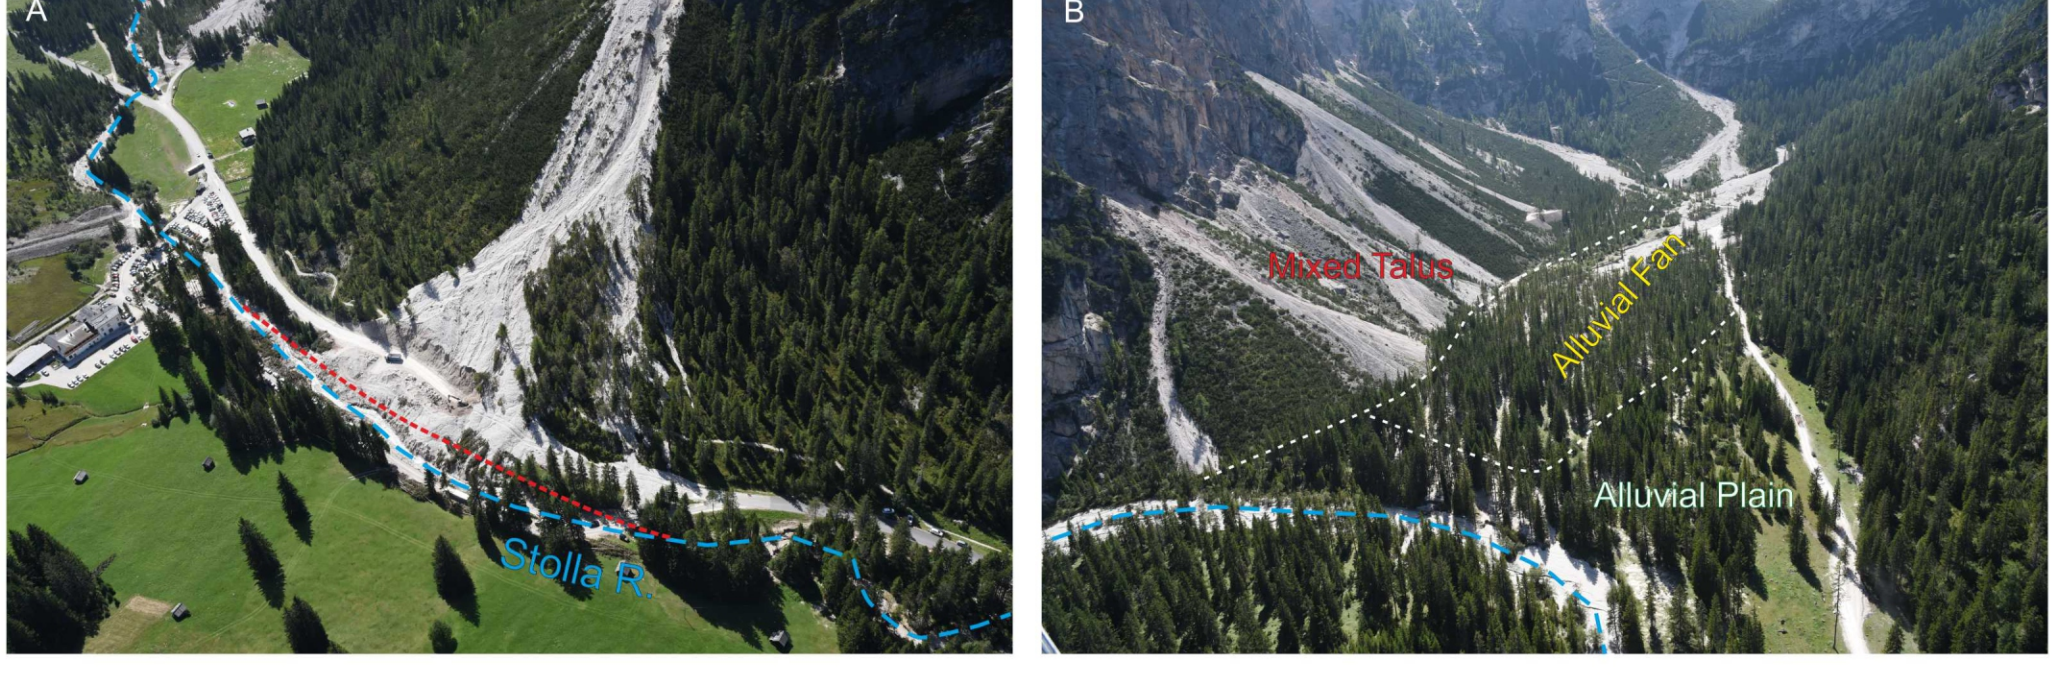
**Figure 13.** Examples of connected (A) and disconnected (B) debris flows in the Stolla catchment.

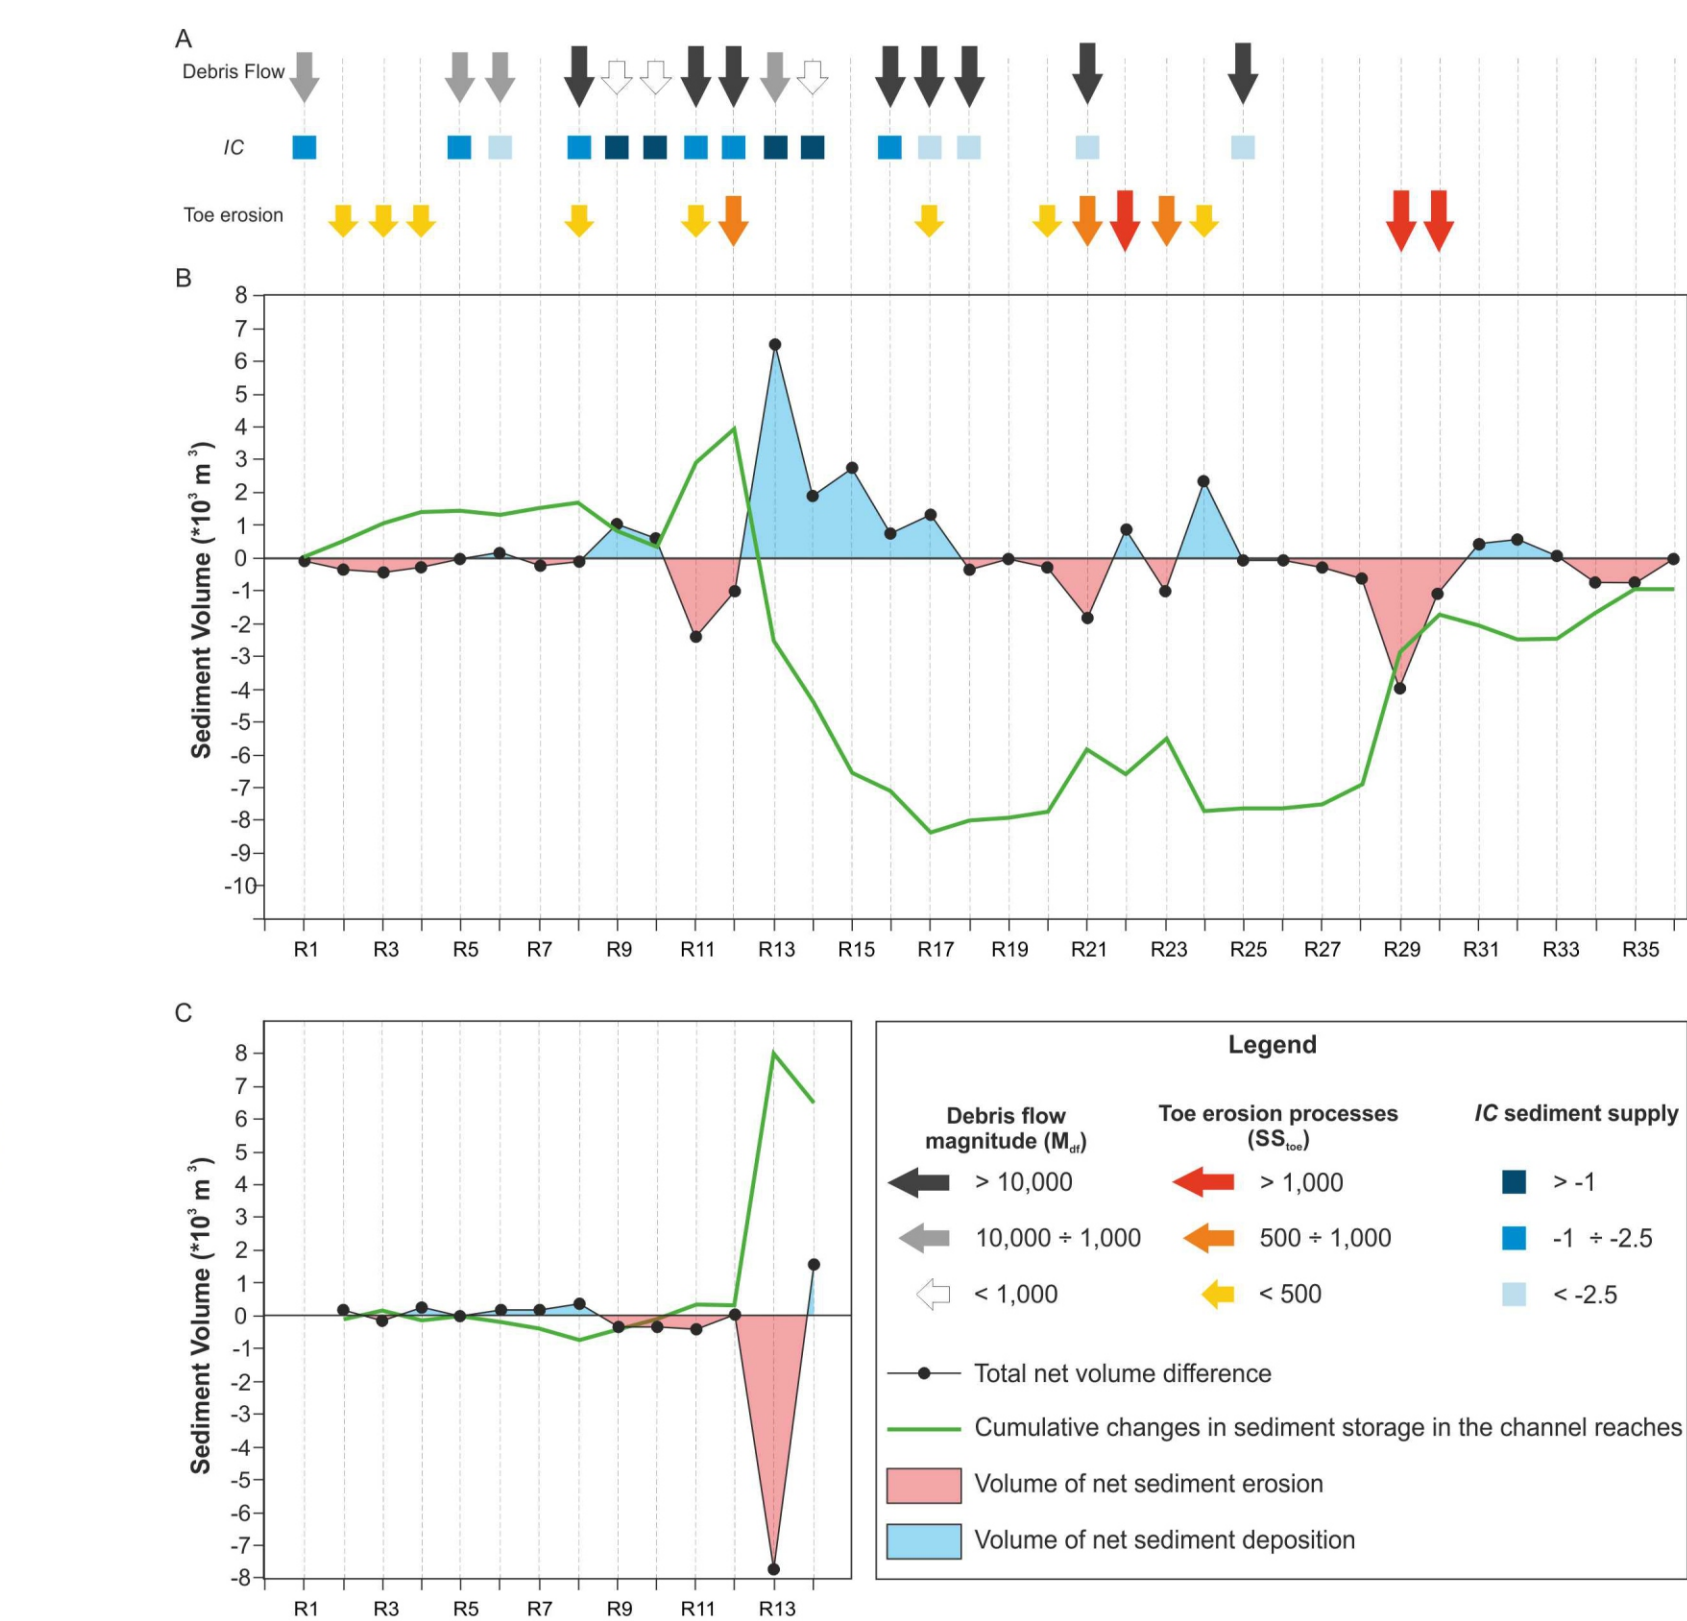
**Figure 14.** Spatial distribution and magnitude of sediment supply for debris flows and toe erosions and of sediment supply for debris flows connectivity during the event in 2017 (A); sediment storage and cumulative changes in the sediment storage in the Stolla channel after the flood event in 2017 (B); and 2020 (C).
